EROSION AND MIGRATION OF AN ARTIFICIAL  
SAND AND GRAVEL ISLAND, NIAKUK III,  
BEAUFORT SEA, ALASKA

Peter Barnes and Thomas Reiss

OPEN-FILE REPORT 82-608

Open File Report 82-608

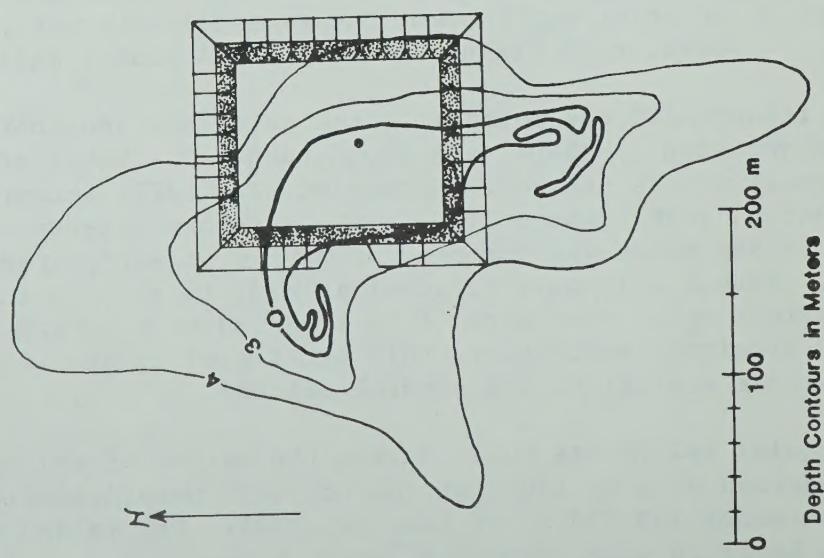
Figure 2a. Niakuk III as originally built superimposed on its shape as determined from the 1980 survey data.

Niakuk III is located on the broad, shallow northwest flank of the Sagavanirktoq River delta-front platform in about 4 m of water. The island was built during the winter of 1978-79. The presumed initial shape of the island when open water first allowed wave and current reworking first occurred in the spring (July) of 1979 is the above-described rectangle. One year later during July 1980, the morphology of the island had changed significantly both subaerially and subaqueously. The northeastern segment of the island was displaced, eroding the shoreline about 80 m. Recurved subaerial spits were developed to the west and south extending 70 to 80 m beyond the original shores of the island. Only the southwest corner of the island appeared in 1980 as it did when built the previous year (Fig. 2a).

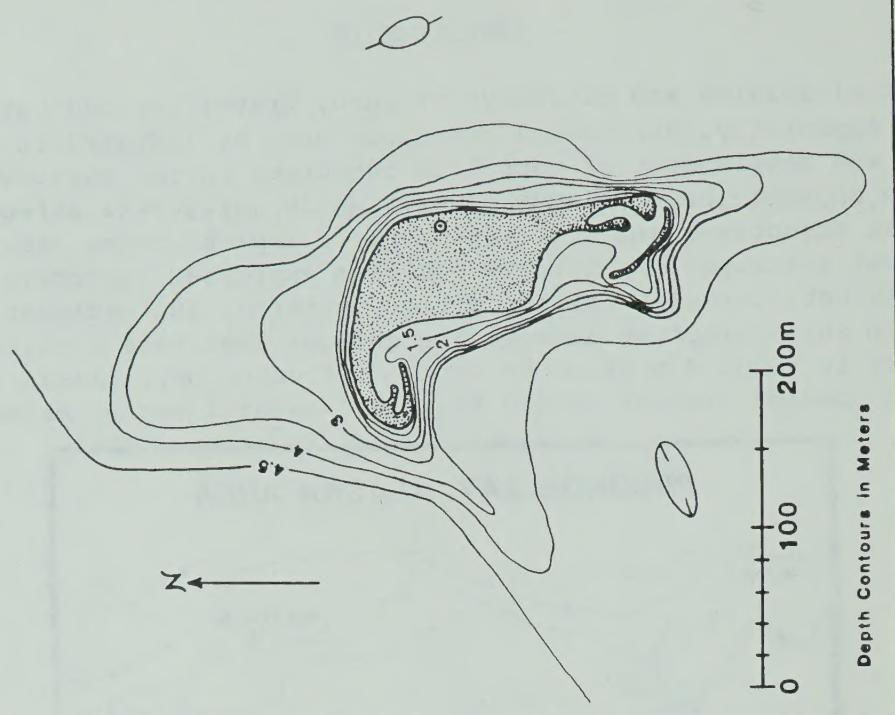
Figure 2b. Detailed bathymetry in the vicinity of Niakuk III from survey in July 1980.

Sediment that was originally part of the island has been redistributed to the west and to the south, covering an area about double the original base area of the island. The steep slopes on the northeast flank of the island drop to approximately pre-island depths within about 40 m of the island. On the north side of the island a platform-like tongue extends about 100 m to the north at 3 to 4 m depth while to the west and south the subaqueous extensions of the spit slope smoothly to the surrounding sea floor (Fig. 2b).

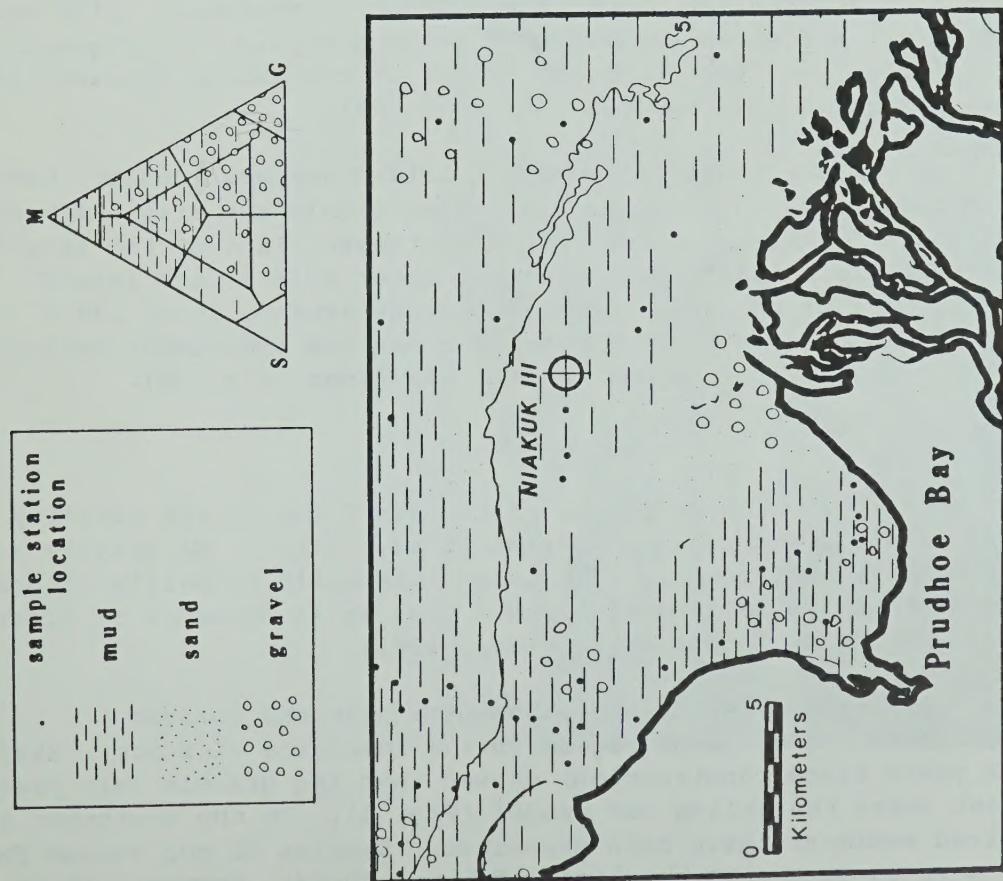
Figure 3. Sediment texture of the sea floor in the vicinity of Niakuk III (after Barnes, et al., 1980).

Prior to construction the sediments of the sea floor in the vicinity of the island were slightly muddy sands (Barnes et al., 1980). No gravels were sampled within several km (Fig. 3). The island was built primarily of gravel, but 5 to 10 percent of the fill was less than 0.25 mm in diameter or finer than medium sand (Northern Technical Services, 1981).

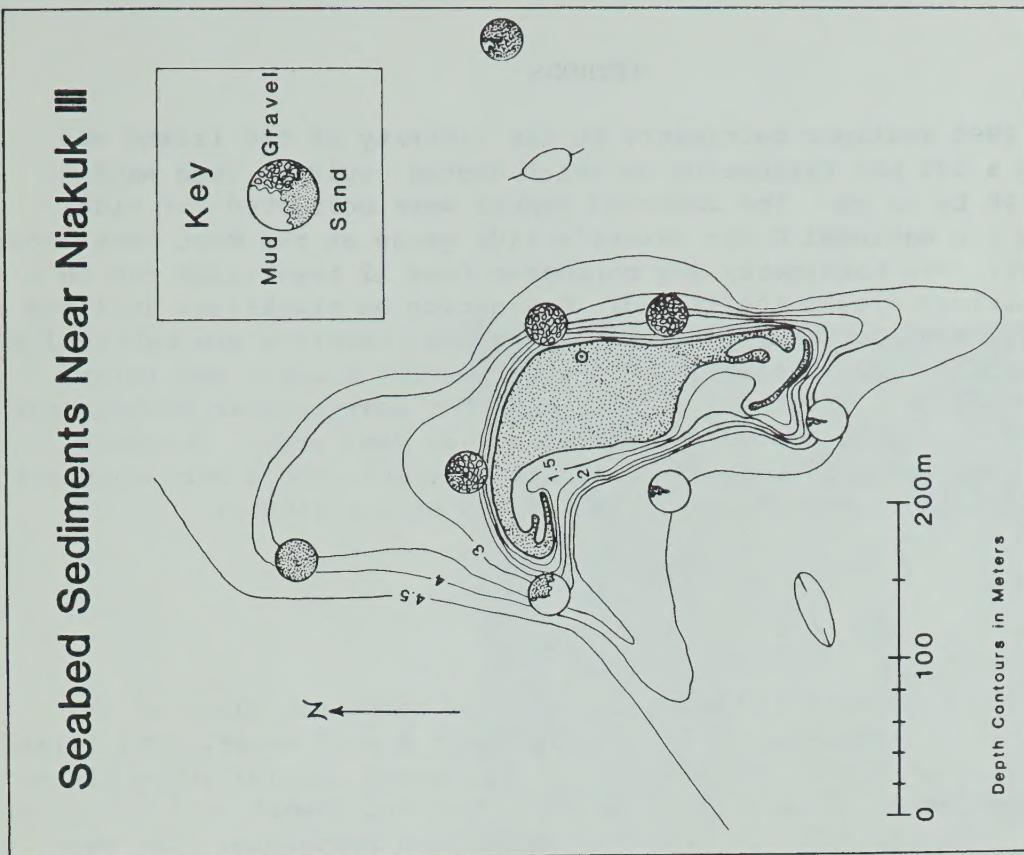
Figure 4. Location and sediment texture of 1980 samples in the immediate vicinity of Niakuk III.

The emplacement of the island and subsequent wave and current modification affected the sediment regime in the immediate vicinity. Sampling in 1980 (1 1/2 years since construction) showed that lag gravels were present to the northeast where the island was eroded (Fig. 4). To the southwest and west fine-grained sediments have been deposited. Samples do not extend far enough to the west to determine the limit of these fines. However, it is apparent that gravels are not being carried beyond the spits of the island.

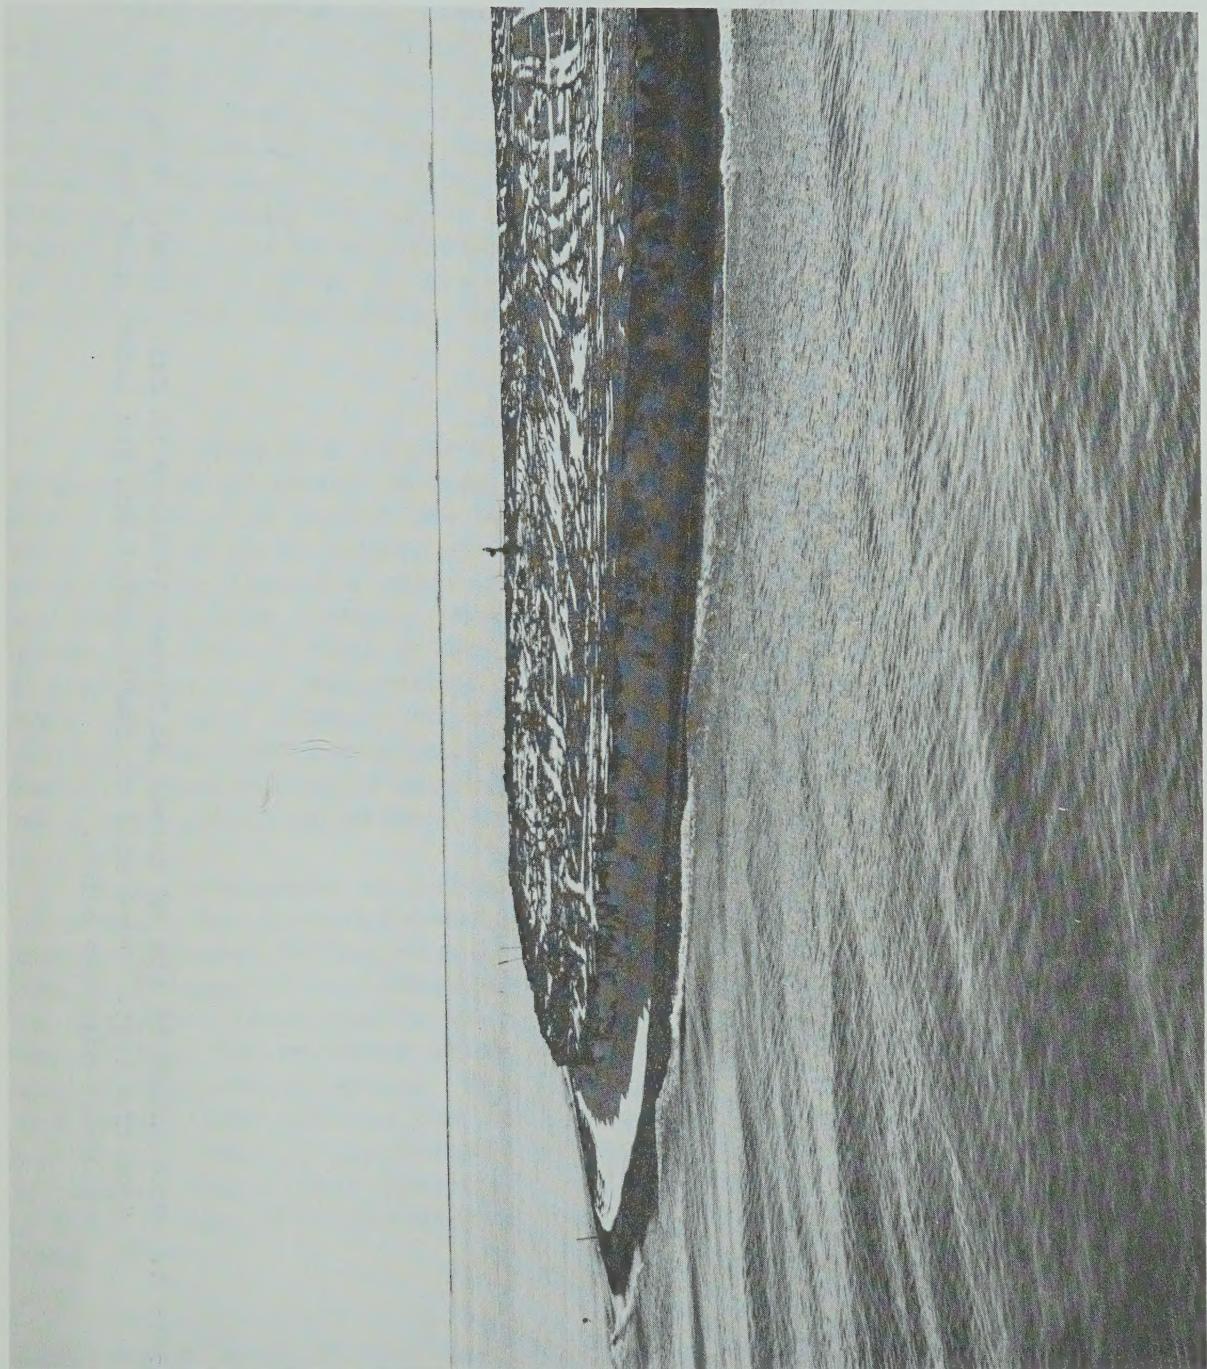
Figure 5. View of the NE corner (left) of Niakuk III taken in September of 1979 (view to the southeast). Note essentially square shape and location of well head.

Visual observations taken in 1979, 1980, and 1981 also indicate the alteration of the island morphology. Photographs taken in the summer of 1979, the summer after construction of the island, show that the northeast corner had become rounded (Fig. 5). By 1980, the year of the detailed survey, the northeast quadrant had retreated further and the spits had been extended. The wellhead was about 15 m from the northeast-facing shore (Fig. 6). When we visited the island in summer of 1981, the wellhead was about 5 m offshore. Furthermore, the island appeared diminished in size, partly due to the removal of 21,600m<sup>3</sup> of gravel at the end of the summer of 1980 for the construction of other islands (Northern Technical Services, 1981).

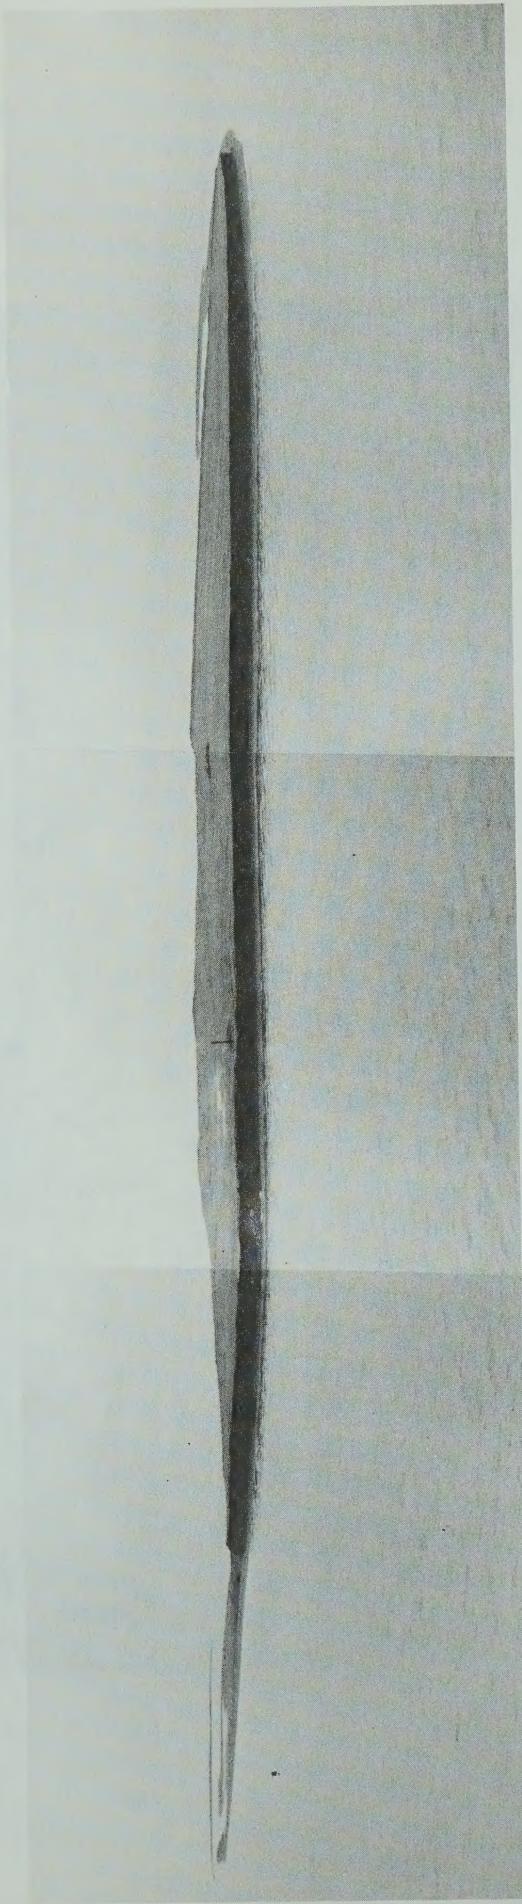
Figure 6. Photograph of the NE corner of Niakuk III taken in July, 1980. View is from the east. Note spit to south (left) and the location of the wellhead near the bluff.

The predominant factor affecting Niakuk III island has been erosion and redeposition of sediment from the northeast quadrant of the island. After being built, the island was exposed to one open-water season (summer 1979) prior to our early summer survey in 1980. Figures 2 and 6 suggest about a third of the island's volume had been displaced from its original emplacement site during this season. Given that the original volume of the island was about 100,000 m<sup>3</sup>, then at least 30,000 m<sup>3</sup> would have been reworked, transported, and redeposited during the open-water season in 1979. This is a very high rate compared to natural coastal sediment transport to be expected for one year for arctic sand and gravel beaches (Nummedahl, 1979). This high rate is believed to be related to the fall storm discussed below or the lack of a substantial permafrost core.
